ULTRASONOGRAPHIC DIAGNOSTICS BY CHOOSING THE METHOD OF SURGICAL TREATMENT OF THE HABITUAL DISLOCATION OF THE PATELLA

Irismetov M.E., Rasulov M.R., Rustamova U.M., Ismatullaeva M.N.
*Republican Specialized Scientific and Practical Medical Center of Traumatology and
Orthopedics, Tashkent, Republic of Uzbekistan*

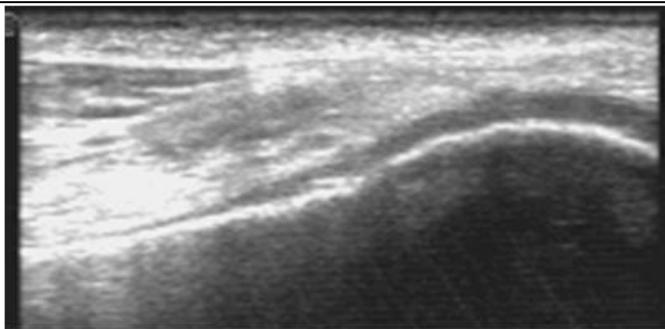
<p>Fig.2a. Damage to the ligament of the first degree. Moderate heterogeneity of the structure, the contours of the ligament are even and clear.</p>

Sonography was used to determine the degree of patellar displacement, depending on the degree of Lig damage. patella-femoralis medialis and own patellar ligament. Damage to the anatomical integrity of the ligament is determined depending on the sonographic picture as follows: the first degree - if part of the ligament fibers is torn, but the mechanical integrity is preserved, while a slight structural heterogeneity is revealed on the sonogram, the contours are even and clear, not crushed; the second degree - there is a rupture of the ligament with the presence of minor defects; the third degree is a complete gap in the bond with the presence of a noticeable defect (Fig. 1 a, b, c). Depending on the degree of damage to the ligaments, the severity of the patella displacement to the lateral side is observed.

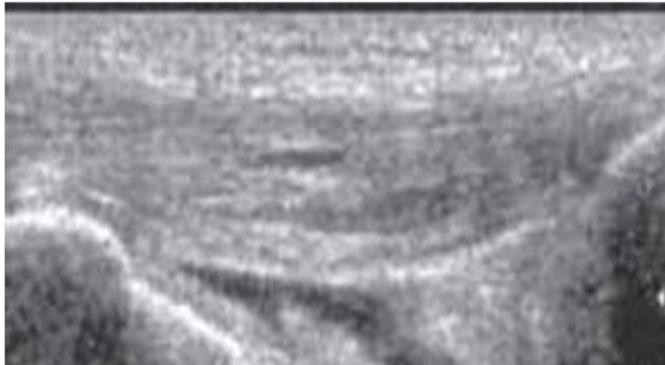
<p>Fig.2b. Damage to the ligament of the second degree. The structure is heterogeneous with the presence of anechogenic and hypoechoic areas in the structure, the ligament is thickened, its echogenicity is slightly reduced. Around it there is a small amount of liquid.</p>

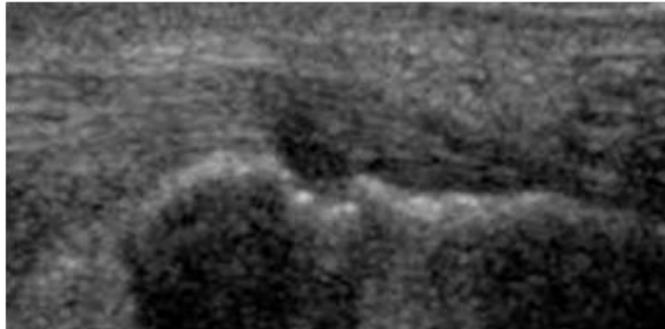
<p>Fig.2c. Damage to the ligament of the third degree. At the level of damage, thinning and moderate deformation of the ligament are noted. Its superficial anterior contour is relatively even and fuzzy, the posterior contour is noticeably interrupted, an anechogenic defect is noted in the ligament structure.</p>

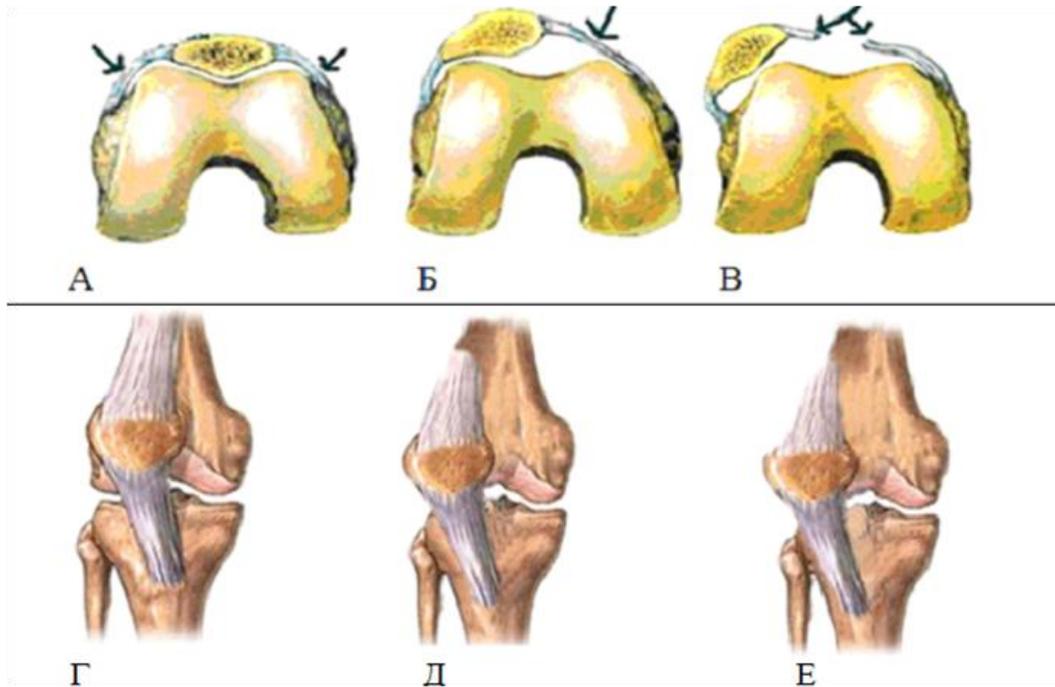
Fig. 3. Schematic representation of the displacement of the patella: A, D - schematic image of the displacement of the patella of the first degree in axial and direct projection; B, D - a schematic image of the displacement of the patella of the second degree with the usual; B, E is a schematic image of the displacement of the patella of the third degree.

Schematically, the anatomical state of the ligaments will look as follows (Fig. 2,3).

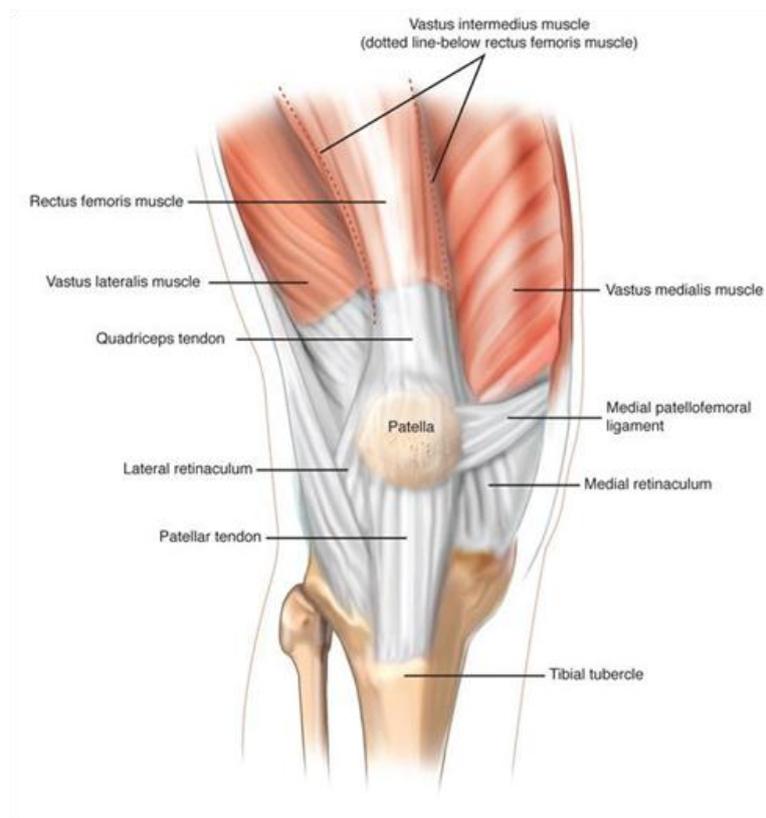
Fig. 3. Schematic anatomical arrangement of the lig. patella-femorales medialis
