Case Report – Restoration Of Mutilated Posterior Tooth

Case report

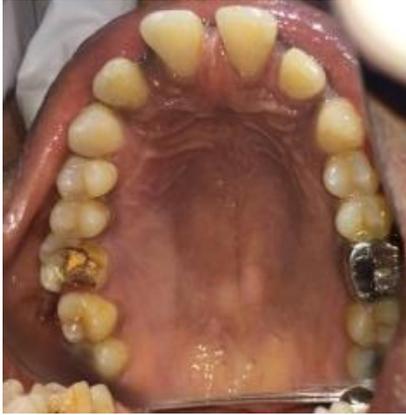
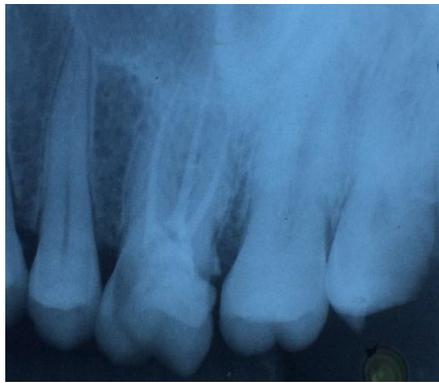
After radiographic examination short obturation was seen with distal root and PDL widening with 26 was seen(fig.1 and fig.2) therefore re-RCT was decided and restore the complex crown fracture with fiber post and core followed by Porcelain fused to metal crown. The gutta percha were removed with the help of retreatment files from all the canals(fig3). Followed by calcium hydroxide dressing was given for 2 weeks. After two weeks Obturation was done with 26(fig 4). The working length of palatal canal was-18mm .Gutta percha was removed till-12mm(fig.5). The canal were prepared till no. 3 peso reamer.

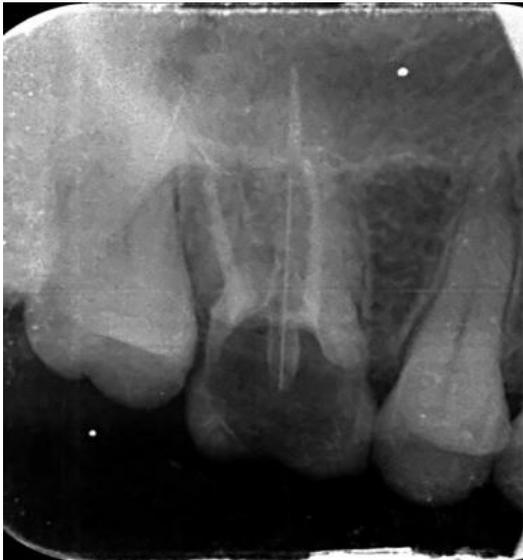
Fig 6

Proper fit of the fibre post was checked with the help of RVG (fig.6) and followed by core buildup with the help of 3m z350 filtek nano composite(fig.7).
